## Architectural Forensics: establishing a date for the construction of Pavitt Cottage, Robinson's Bay, Bank's Peninsula

William Cottrell, PhD candidate, Art History, School of Humanities, Canterbury University

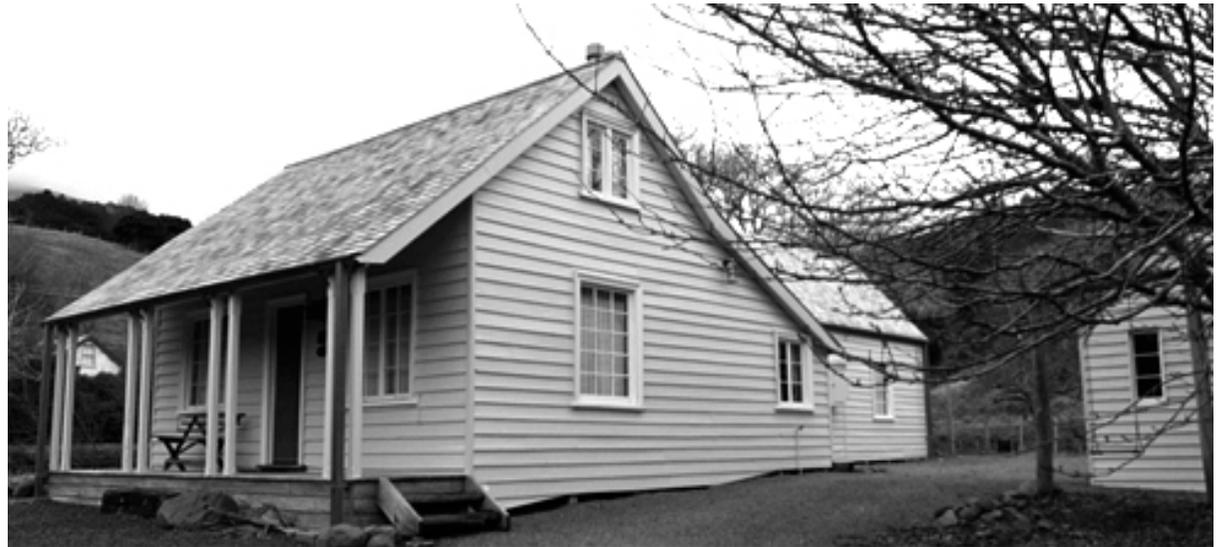
**Figure 1:** Pavitt Cottage, Robinsons Bay, Banks Peninsula built sometime between 1857 and 1862. The newer 1870+ wing is just visible to the rear.

Pavitt Cottage [built c1857-62] is a small weather-board dwelling of conventional colonial character originally having a roughly square footprint and with a later c1870+ two room wing to the north-east rear side. The older front portion has a 2x2 room ground-floor plan with two small bedrooms upstairs in the peaked roof cavity. Likely there were once three rooms as indicated by a redundant door off the landing on the south side. There is a full-length verandah across the front of the house with the front entrance door

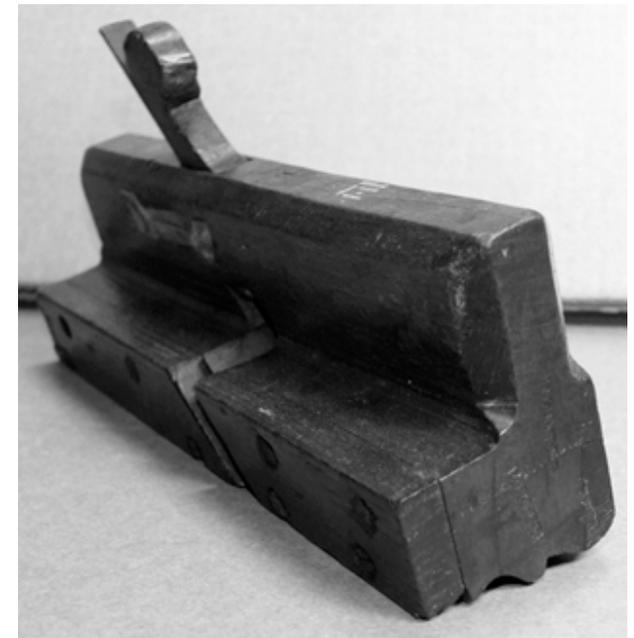
Figure 2: Hand moulding plane made about 1840 with a Grecian ogee profile as used on Pavitt Cottage.

The entire interior decorative treatment is limited to the varied and imaginative use of merely five moulding profiles to create the widest decorative effect. Some internal joinery was complex and demonstrated a high proficiency of hand work and familiarity with wood skills. Cabinet-makers often had as many as 20-30 different moulding planes but carpenters had far less. This hints here to a carpenter with a small kit of planes dedicated to decorative treatment for house building.

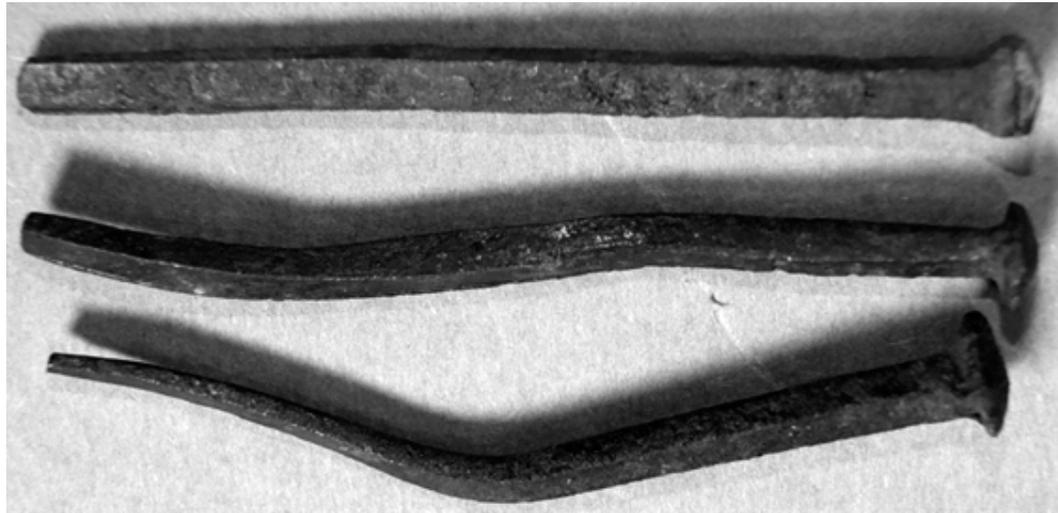
**Figure 3:** The two patterns of Ewebank nails recovered from Pavitt Cottage. (top & middle: 1834-1869 with bulbous taper on one plane and burrs caused by parallel rollers; bottom: c1850-1860 tapering on all four sides produced by converging rollers [head pattern · × · ])

Nails can indicate time-frames of manufacture and subsequent periods of likely use. Nails recovered from Pavitt Cottage are of sliced and stamped or sheet cut types. They conform to the "Ewebank" pattern and none were found to have that maker's characteristic post-1869 *star* impressed on the head.

Two head patterns were noted to the largest nails. One removed from the interior of the front downstairs bedroom cupboard had irregular faceted head consistent with the earliest Ewebank nail pattern dating from after 1834. It had [machine] ejection finger marks to the upper shaft below the head while the shaft middle had the typical Ewebank bulge. The head had compression fractures indicating it may not have been red hot and lost some plasticity while being forged. Most importantly it had raised ridges to top and bottom edges of its parallel sides caused by eccentric rollers on the "patented" milling machine squeezing and elongating the heated nail rod into a new cross-sectional form. Historian Chris How has surveyed early Australian buildings and notes that: "Miles Lewis ... has located Ewebank nails as far back as 1837."<sup>10</sup>

The second nail retrieved on this survey was found in the attic part of the newer wing and had consequently degraded more because of damp. There was an unidentified "Dot X Dot" impression to its head and had a regular four-sided tapering shaft. Another development of Henry Ewebank's was a machine with

converging rollers to draw out the nail and taper it to a point.<sup>11</sup> There were clear impressions of machine stamping to form the nail head as can be seen from the folded metal under the nail head. They are on diagonally opposite "corners" of the nail shaft suggesting two <> shaped vice heads gripping the nail as the head was hammer formed in a mould.

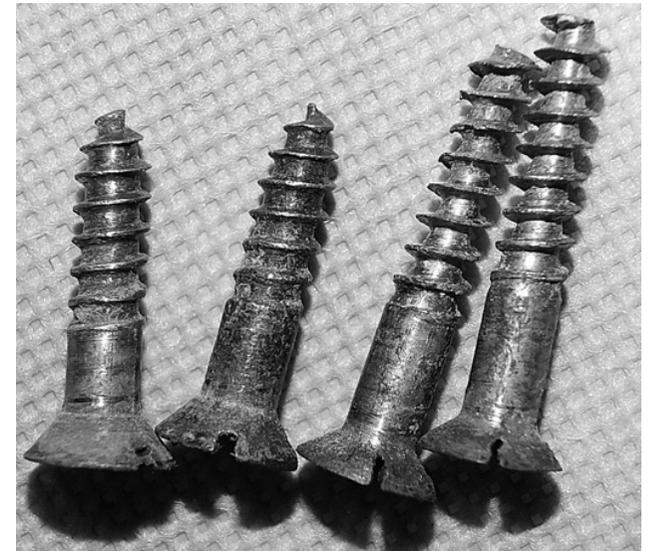
**Figure 4:** Screws all recovered from one door hinge. (left: Pointed Nettlefold pattern 1854-58; right: Whitworth post 1834 pattern)

Screw patterns are a very good indicator of age. Four were randomly removed from a black, cast-iron butt hinge. They were extremely informative and supported the time-line evidence in wood processing already discussed. Two screws had blunt tips, non-tapering shafts and deeply cut, very sharp

threads when compared to the other two shorter [later] screws. The two types were made quite differently, most significantly in the way the thread was formed.

The blunt-tipped screws had their threads cut on a die which was wound onto the blank screw rod, rotated to cut the thread. This is quite evident where the metal has been pushed sideways by the cutter's pressure to create a double lip to the initial thread. Joseph Whitworth patented his un-locking clasp nut for forming threads in 1839. The advantage was that it did not need rewinding back down the threaded screw shaft. Its use was commonplace when he displayed it at the 1851 Great Exhibition. This "blunt" screw pattern is typically English and can be found in New Zealand furniture until the middle to late 1850s.<sup>13</sup>

The metal on all four screws has been squashed while hot causing the thread to rise beyond the original extruded rod blank diameter. In 1847 New Yorker Thomas Sloan patented his machine for forming pointed screws and in 1854 Englishman John Nettlefold bought the rights to manufacture those screws from Sloan's invention. By 1858

The pattern of the two "pointed" screws followed the American model. Their counter-sunk heads were angled steeper and the slots wider. Interestingly they had a rounder outer flange as though they were not entirely tool cut on a lathe but possibly stamped. No chuck or grip marks were seen on any screw upper shaft perhaps implying more automation.

The important point to note is that those two screws tapered to a point quickly rather than the "slow" progressive taper of slightly later made screws. These are in fact the first totally machine formed pointed pattern screws. It is clear that both screws [blunt and pointed] were available during the construction of the initial stages of Pavitt Cottage. The former [blunt] screw type necessitated the carpenter to pre-drill the guide hole to the entire screw length and to the exact diameter of the thread trough. The "pointed" screw could drive its own thread once it engaged in the guide hole which could be started with a simple awl. A faster and simpler process. The screws identified for this study from the older part of Pavitt Cottage were all manufactured before
