# Heritage Preservation, Conservation and/or Restoration: Old Government Buildings in the 1990s

Tasmin Falconer, Heritage New Zealand Pouhere Taonga

**ABSTRACT:** In the 1990s, a \$25 million project under the management of the Department of Conservation restored the "largest wooden office building in the Southern Hemisphere," converting it into the home of the Victoria University of Wellington School of Law. The restoration project took roughly the same length of time as the original construction. This paper will present the 1990s work on Old Government Buildings as a case study of heritage practice in the 1990s. We will discuss aspects such as the retention of the heritage lift, the reinstatement of "chimneys" using 1990s construction techniques, use of native timbers, and the decisions made on replication, restoration and strengthening that may or may not be made differently today.

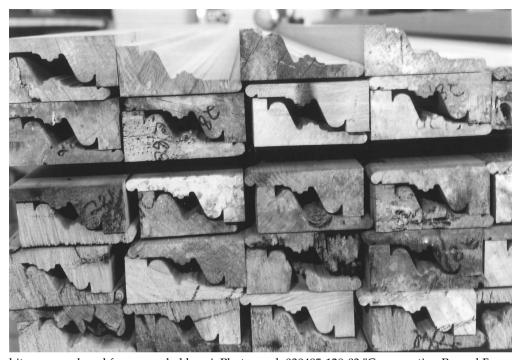
**Figure 2:** Architraves produced from recycled kauri. Photograph 030495-128-03 "Conservation Record Form no. 200-60-c Timber: Running of joinery (10 May 1995)" File No. 13002-232 Ba Vol.1j, Heritage New Zealand Pouhere Taonga, Wellington.

Conservation Plan recommended restoration of missing elements from the 1876-1907 period including, in the interior, "missing cornices, picture rails, architraves, skirtings, dados, dado rails, glazing to doors, doors and window and door hardware."41 There is no specific discussion regarding the use of particular timber species, especially where they might have become rare in the intervening years, but a general principle of using similar materials. The restoration project used demolition timber where original material could not be kept or new components The Department of were required. Conservation update newsletter explained that:

Kauri timber is not in plentiful supply and the Woods Consulting Group, who are managing the restoration work on behalf of the Department of Conservation, has been obliged to scour the country seeking out good quality demolition timber that can be cut, machined and dressed to replace damaged or lost areas of flooring and joinery.
